Chapter 6

Ecosystem Health

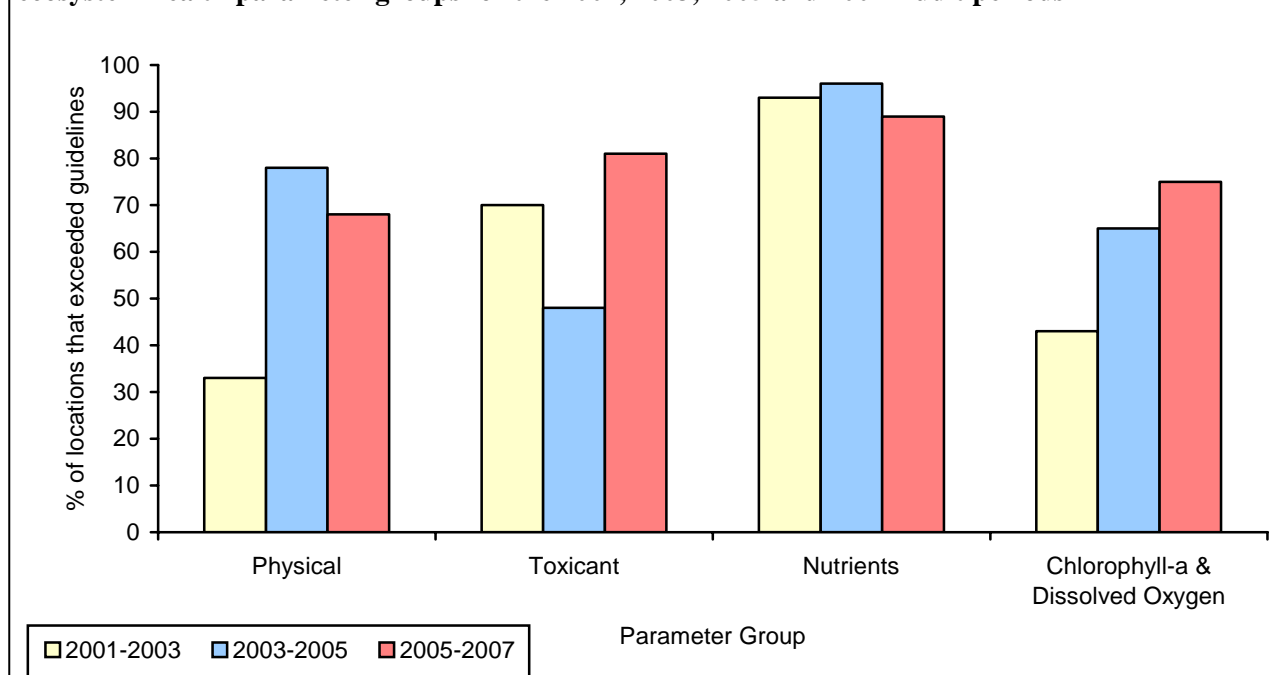
Figure 6.2: Percentage of locations that exceeded the ANZECC and ARMCANZ 2000 guidelines for ecosystem health parameter groups for the 2001, 2003, 2005 and 2007 Audit periods

During the 2003 and 2005 Audit periods, it was noted that the majority of the exceedences of water quality guidelines related to the Nutrient parameter group. The majority of exceedences during the 2007 Audit period were still for Nutrients; however the difference between the groups has slightly decreased from the 2005 Audit period. All four parameter groups now have guideline exceedences at more than 60 per cent of sites (Figure 6.2). Trends at individual sites are presented in Table 8 Appendix C.

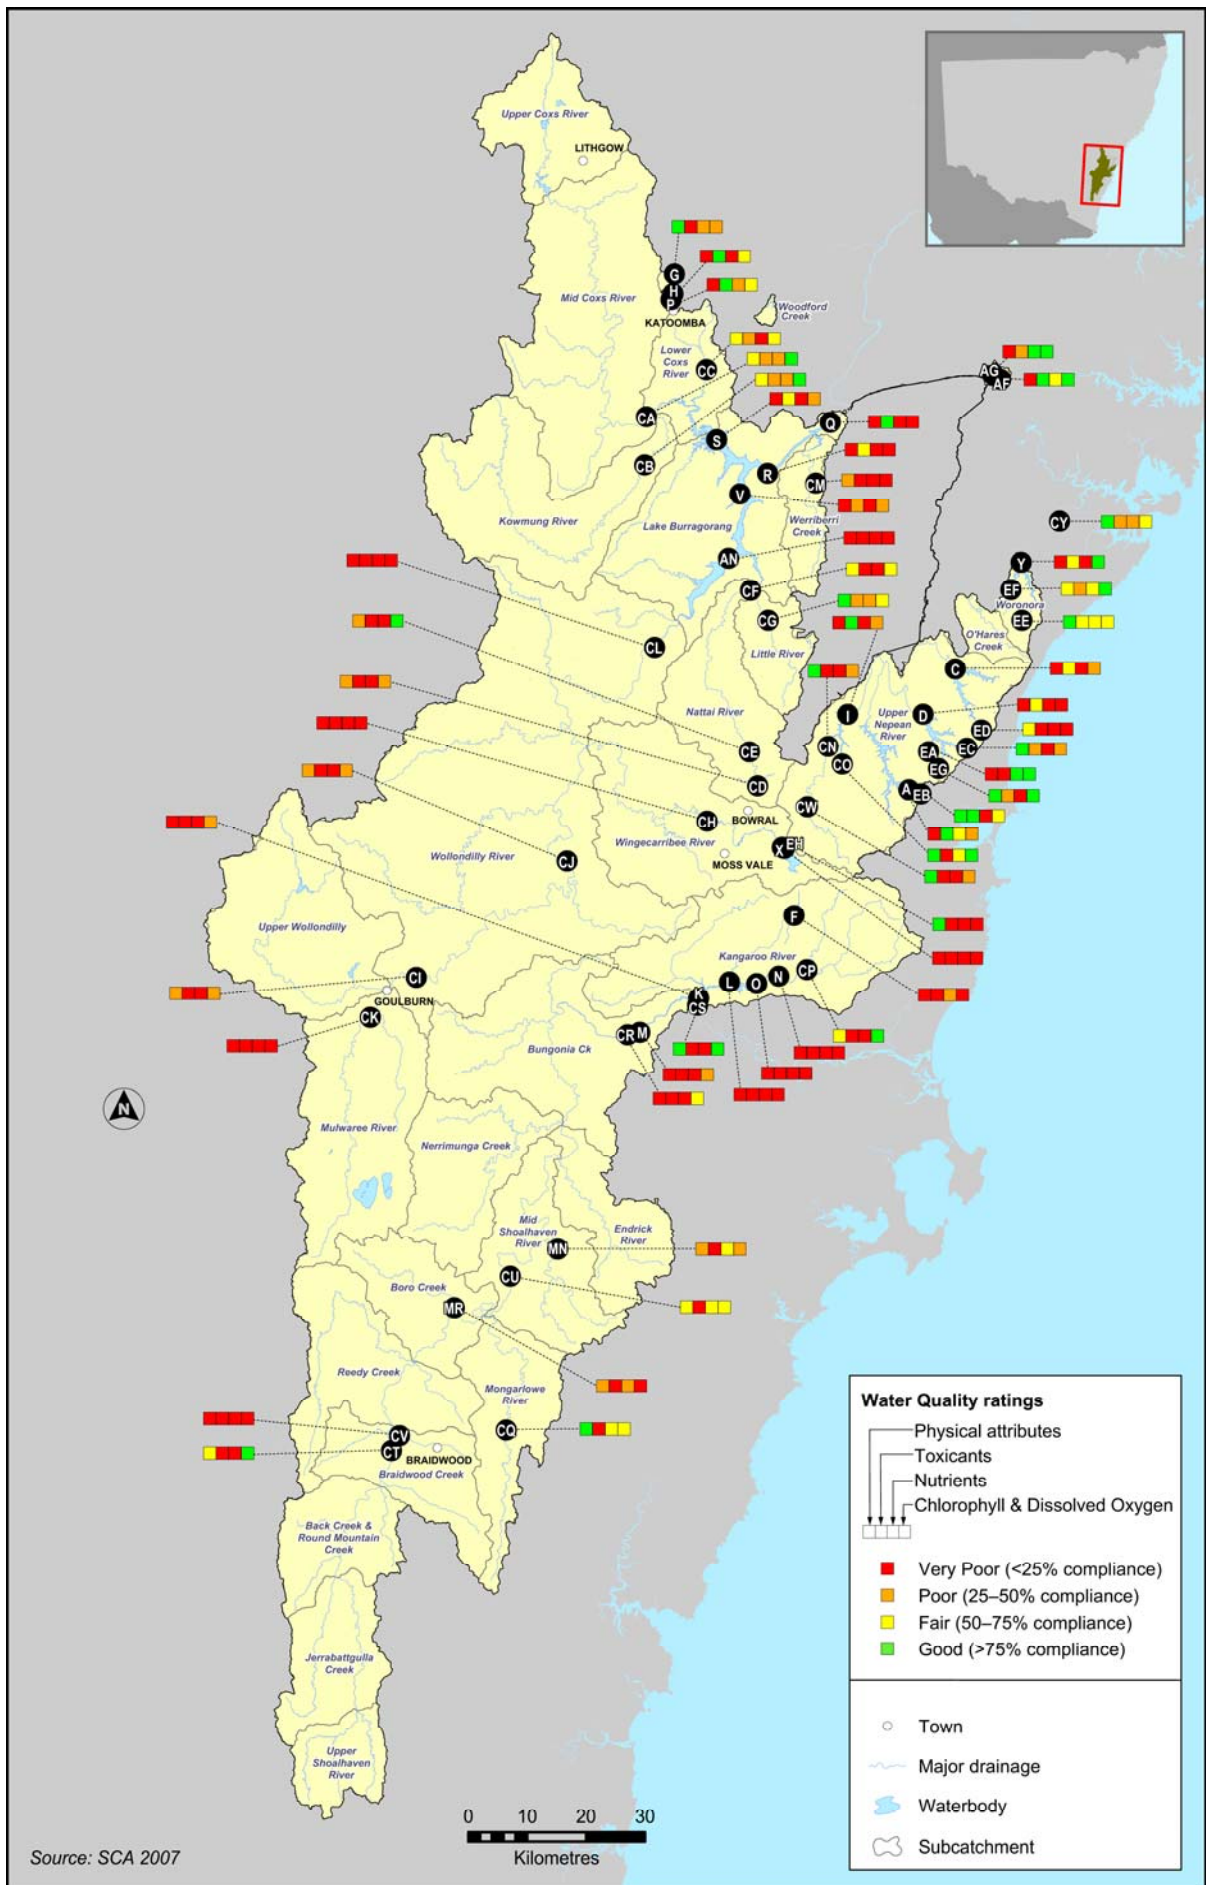
Map 6.1: Water quality monitoring sites showing the 4 parameter groups and percentage compliance in the Sydney drinking water catchment

Five sites had one or two ‘poor’ ratings but no ‘very poor’ ratings. These included the Coxs River at Kelpie Point ^(CA*), Kowmung River at Cedar Ford ^(CB*), Little River at Fireroad ^(CG*), and two sites on the Woronora River ^(EF* & CY*) (Map 6.1).

Shoalhaven River at Fossicker's Flat has similarly declined in AusRivAS health ratings, from similar to reference condition in 2004, to significantly impaired in both 2005 and 2006. The site has also experienced a concurrent decrease in water quality in 3 out of 4 water quality parameter groups since the 2005 Audit period (Maps 6.1 and 6.2).

The Nattai River at Smallwood's Crossing has maintained its high exceedences of water quality guidelines across all four parameters, and has declined in AusRivAS health ratings from similar to reference condition in 2004, to significantly impaired in both 2005 and 2006 (Maps 6.1 and 6.2).

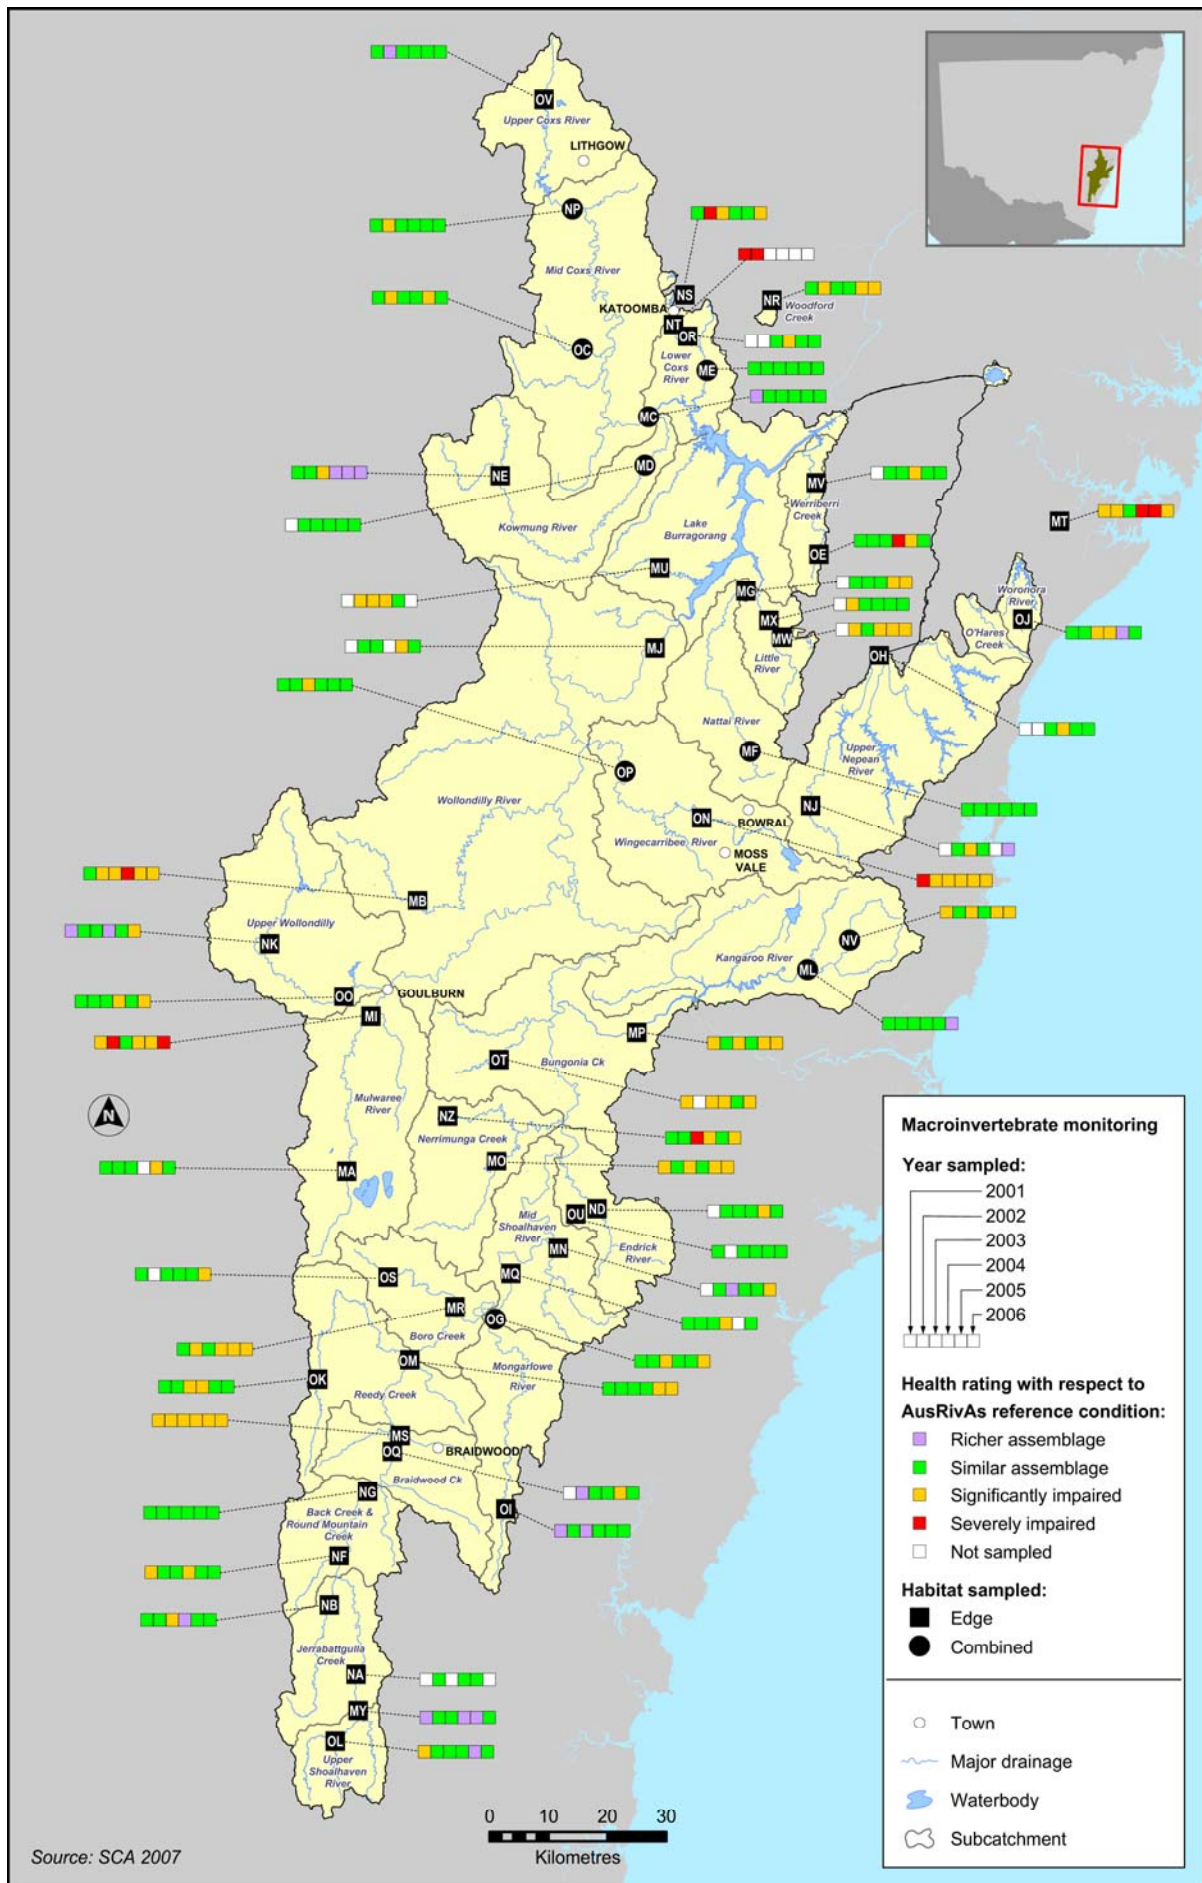
Map 6.2: Macroinvertebrate AusRivAS health rating for Spring 2001 to Spring 2006 in the Sydney drinking water catchment

Werriberri Creek at the Oaks ^(OE*) had a significantly impaired macroinvertebrate assemblage in 2004, which subsequently improved to significantly impaired in 2005, and then to reference condition in Spring 2006 (Map 6.2).

Jacqua Creek at Lumley Rd ^(NZ*) received an AusRivAS health rating of severely impaired during Spring 2003. It improved to significantly impaired in Spring 2004, to reference condition in Spring 2005, then worsened to significantly impaired again in Spring 2006 (Map 6.2).

Yosemite Creek upstream of Minnihaha Falls ^(NS*) received a severely impaired rating in 2002, but has moved back and forth between reference condition and significantly impaired ratings since. In 2006 it was significantly impaired (Map 6.2).

Overall, eight sites have received consistently poor ratings (no more than a single rating at similar or greater than reference condition) across the 2001-2006 sampling periods. These were Gillamatong Creek at Braidwood ^(MS*), Bungonia Creek at Bungonia ^(OT*), Tonalli River upstream of Basin Creek ^(MU*), Blue Gum Creek along fire trail W41 ^(MW*), Mulwaree River at the Towers ^(MI*), Wingecarribee River at Berrima ^(ON*), Upper Tarlo River at Tarlo ^(MB*), and Woronora River at the Needles ^(MT*) (Map 6.2).

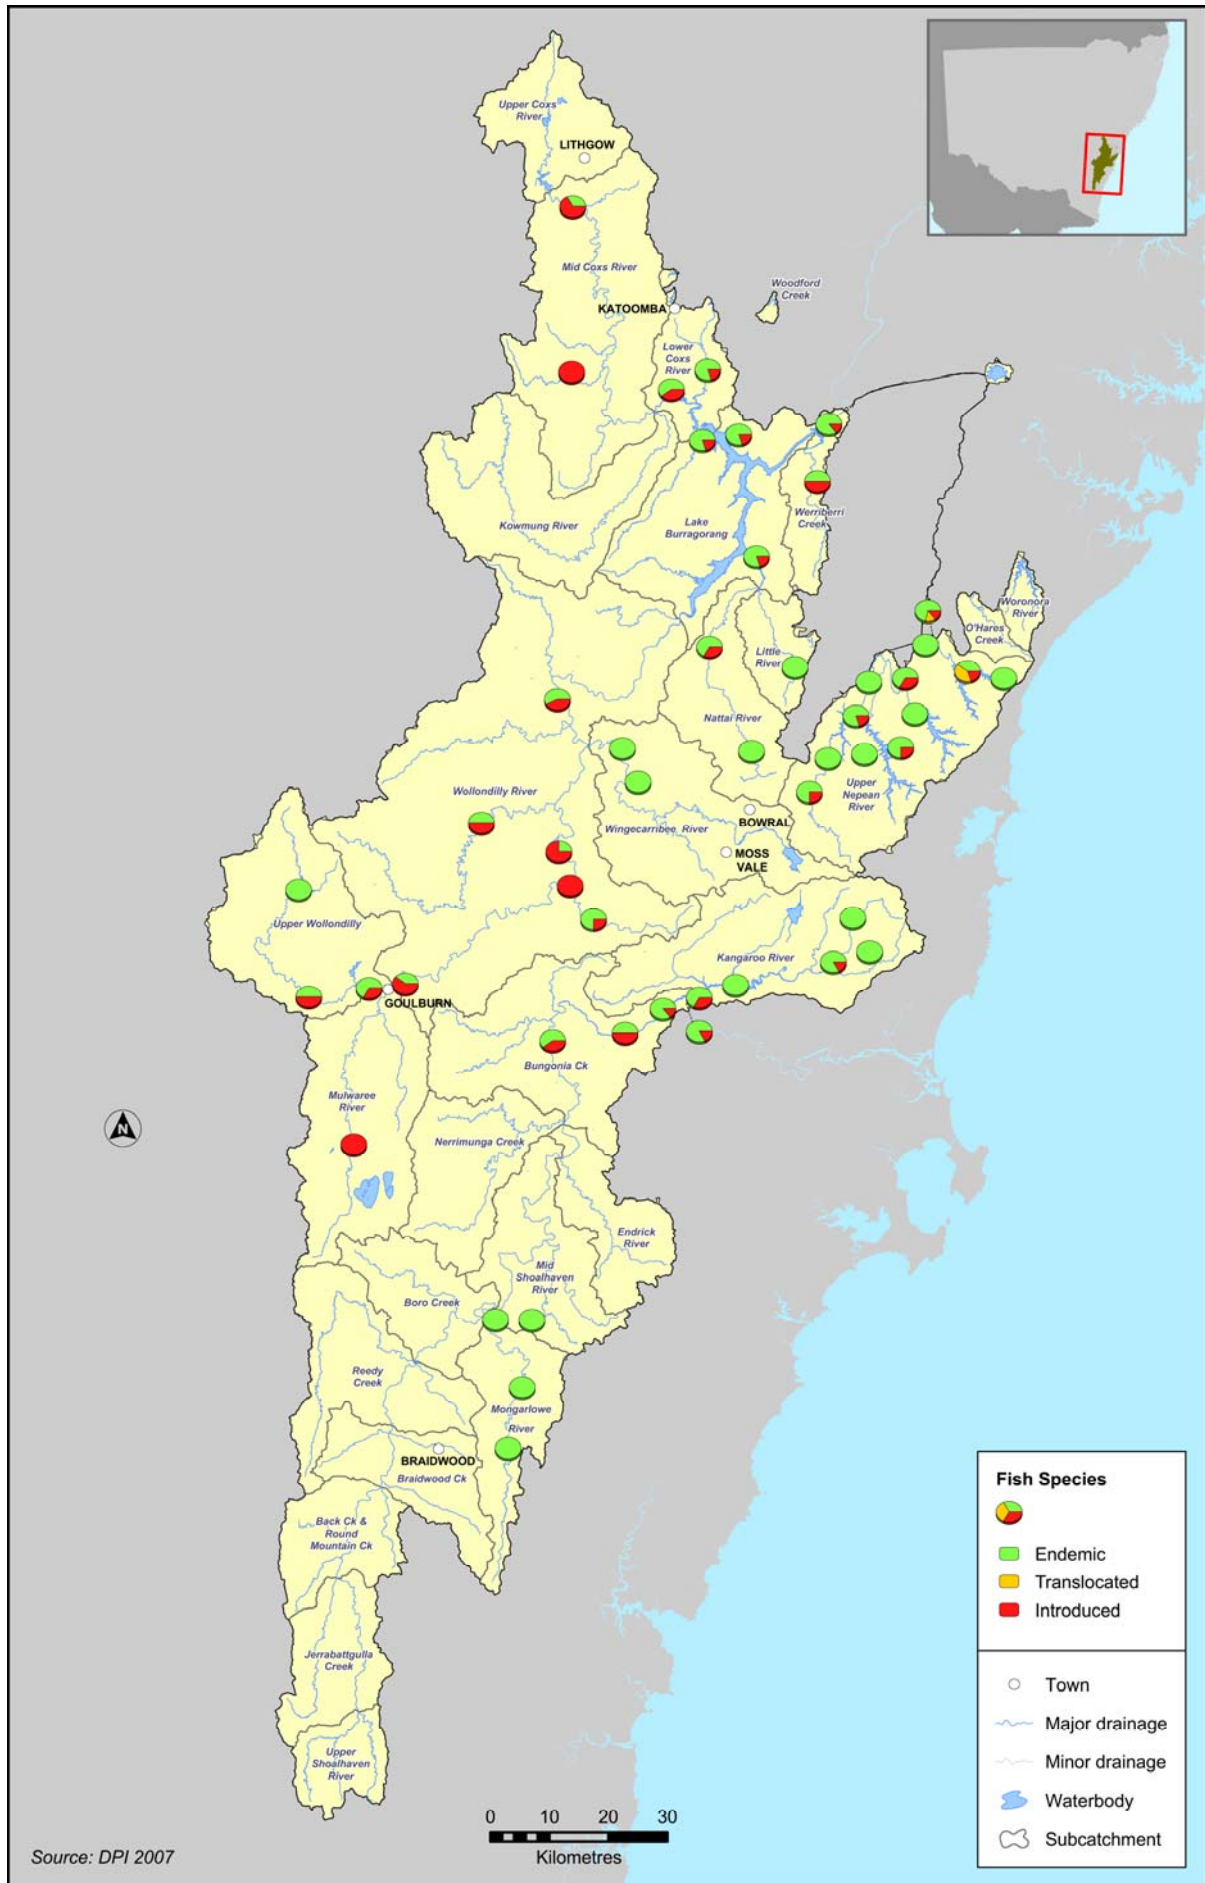
Map 6.3: Endemic, introduced and translocated fish species in the Sydney drinking water catchment

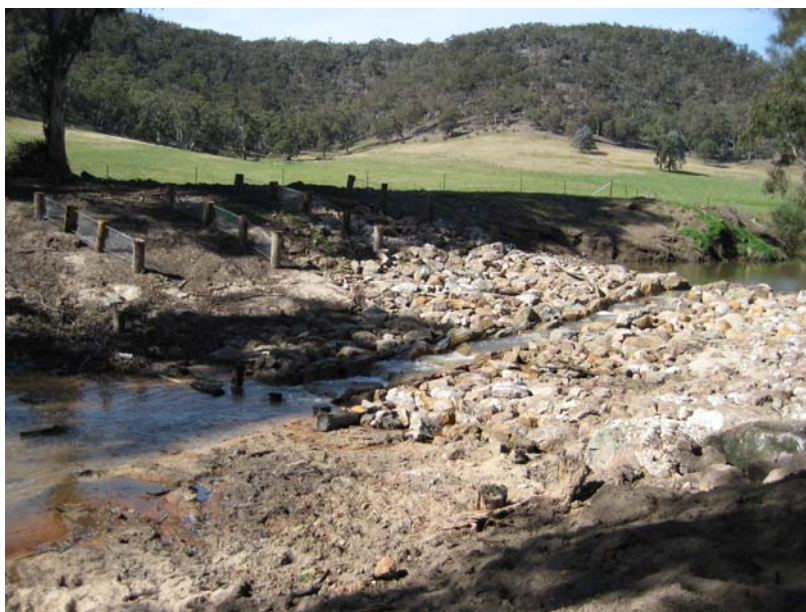
Figure 6.4: Black Bobs Creek fishway and bank stabilisation works

During the 2007 Audit period, a fishway was built on Black Bob's Creek (a DPI site of medium priority remediation work), which was undertaken in conjunction with other works to stabilise banks and improve instream habitat (Figure 6.4).

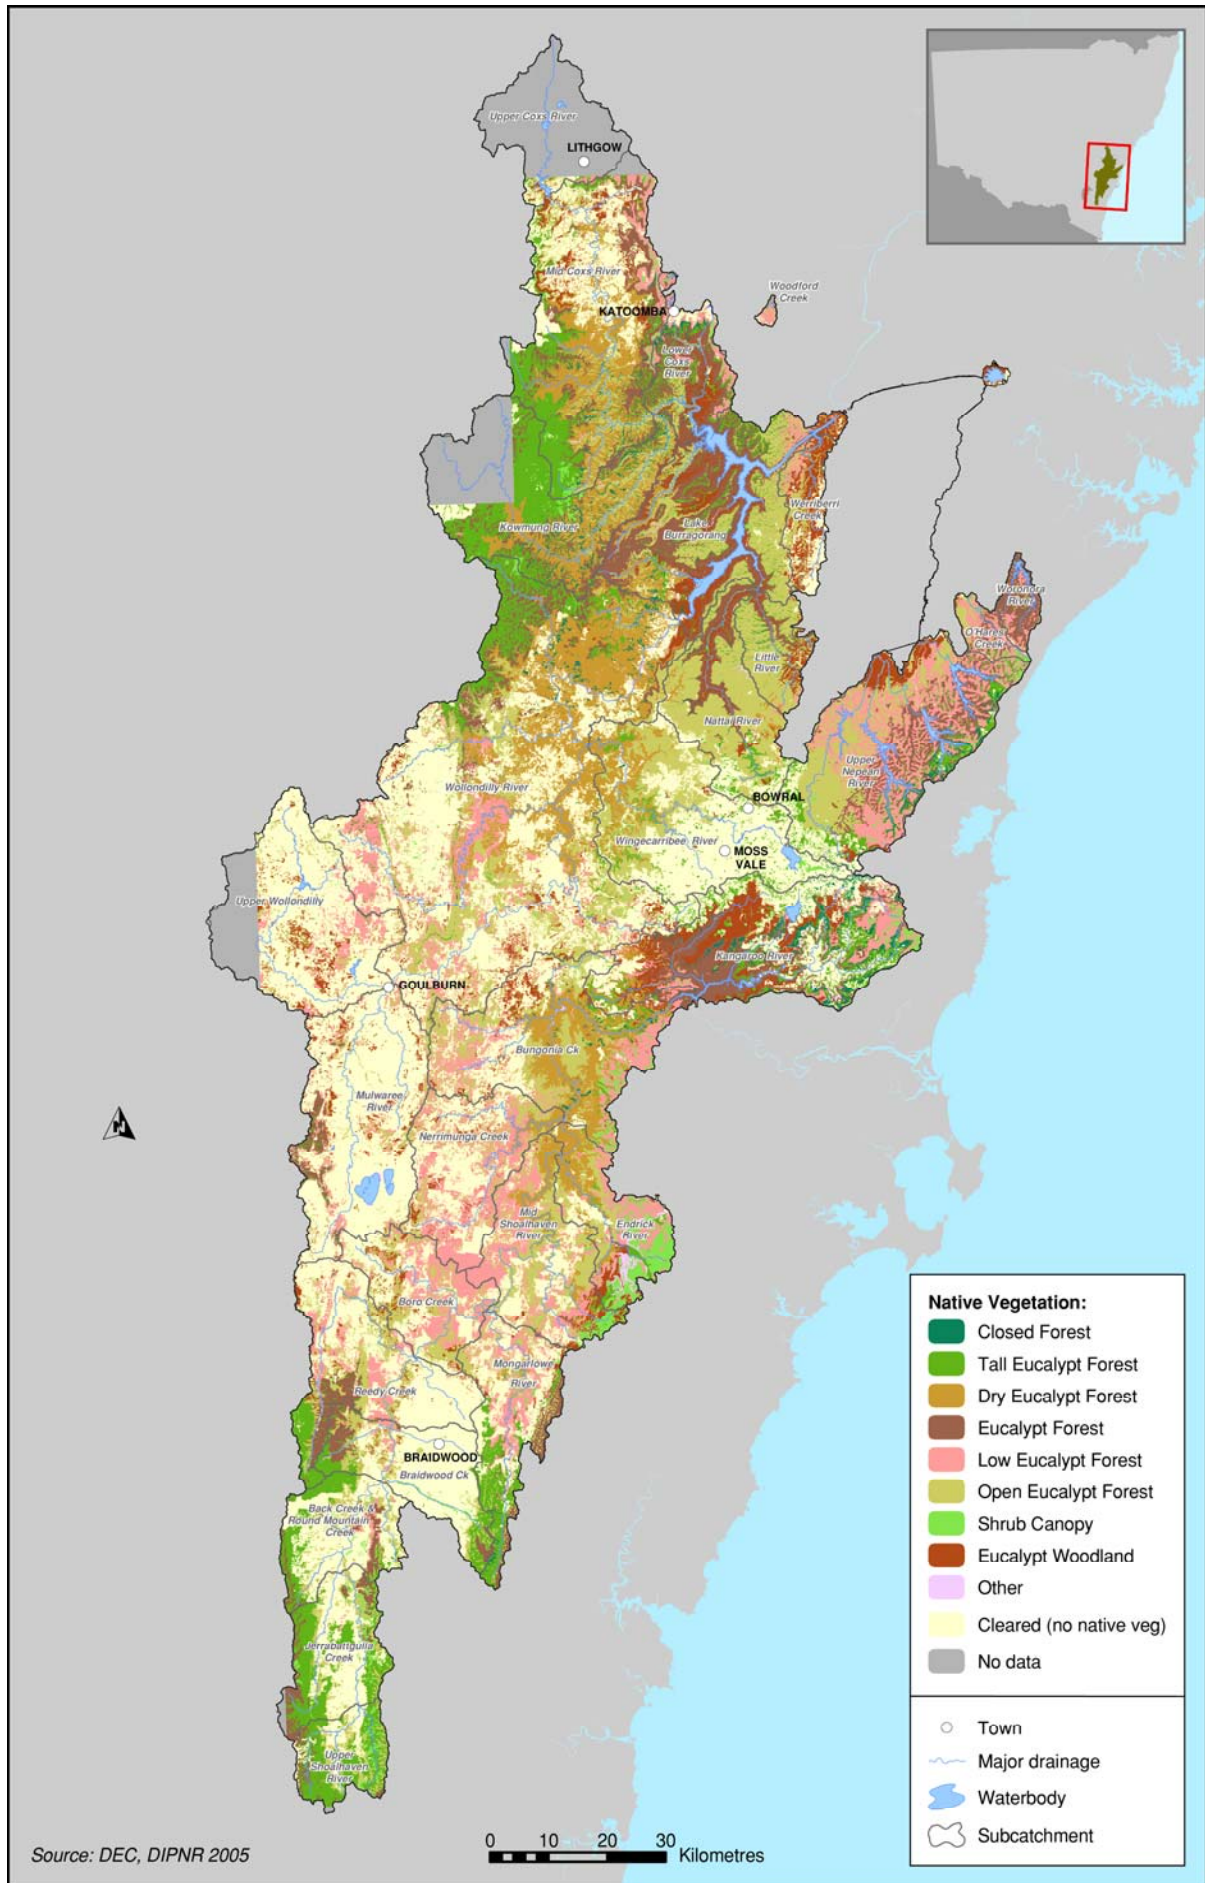
Map 6.4: Native vegetation in the Sydney drinking water catchment

The lowest percentage of native vegetation cover in 2005 was in the Upper Wollondilly River (priority) and Mulwaree River (priority) sub-catchments. The low percentage cover of native vegetation in these sub-catchments may put water quality and ecosystem health at risk.
